Manhole Inspection Summary

Manhole # S45KK_046MH

Insp Date: **4/2/08 12:52 PM**

Location Address: **Wolfe St**

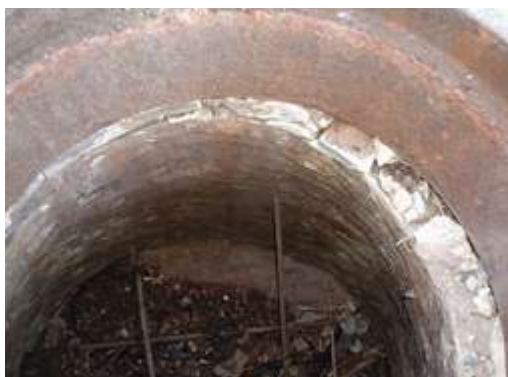
Defect 1

Condition: ☐ Sound ☐ Cracked ☐ Root Intrusion ☒ **Loose Brick** ☐ Deteriorated

Infiltration: ☐ None ☐ Joint ☐ Cracks ☒ **Mortar** ☐ Roots ☒ **Wall**

Loose Bricks

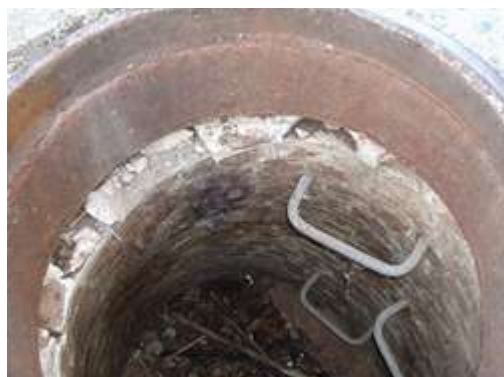
Defect 2

Frame Offset: **2** (in.) Condition: ☐ Sound ☐ Cracked ☒ **Leaks**

Offset

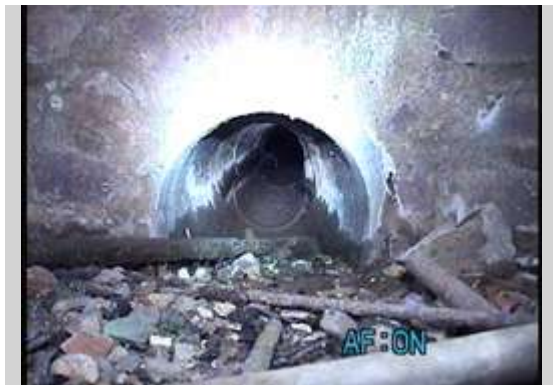
12 O'Clock Outflow

8 in. Circular Gravity Sewer
Pipe Out @ 12 O'Clock

Deposits: ☐ None ☒ **Mud** ☐ Sludge ☒ **Debris** ☐ Grease

Silt Depth: **3** (in.) Deposits Extent: **Medium**
